THE MALDEN SURVEY

A REPORT ON THE CHURCH PLANTS OF
A TYPICAL CITY, SHOWING THE USE
OF THE INTERCHURCH WORLD MOVE-
MENT SCORE CARD AND STANDARDS
FOR RATING CITY CHURCH PLANTS

WALTER SCOTT ATHEARN

Copyright 1920 by the
Interchurch World Movement
of North America

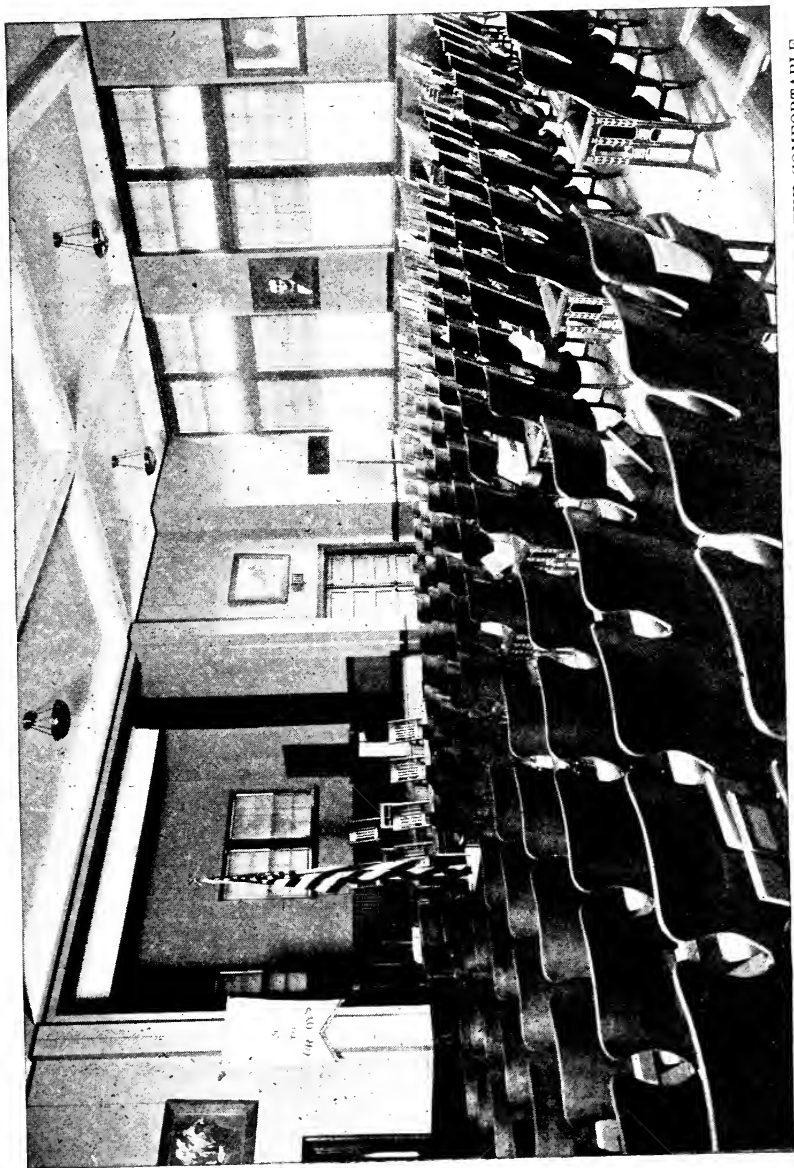
ILLUSTRATION 82. THE ADULT ASSEMBLY OF THE FIRST BAPTIST PARISH HOUSE. NOTE THE COMFORTABLE SEATS, THE WELL SELECTED PICTURES AND THE INDIRECT ARTIFICIAL LIGHTING. UNFORTUNATELY, NATURAL LIGHT COMES FROM THE RIGHT ONLY

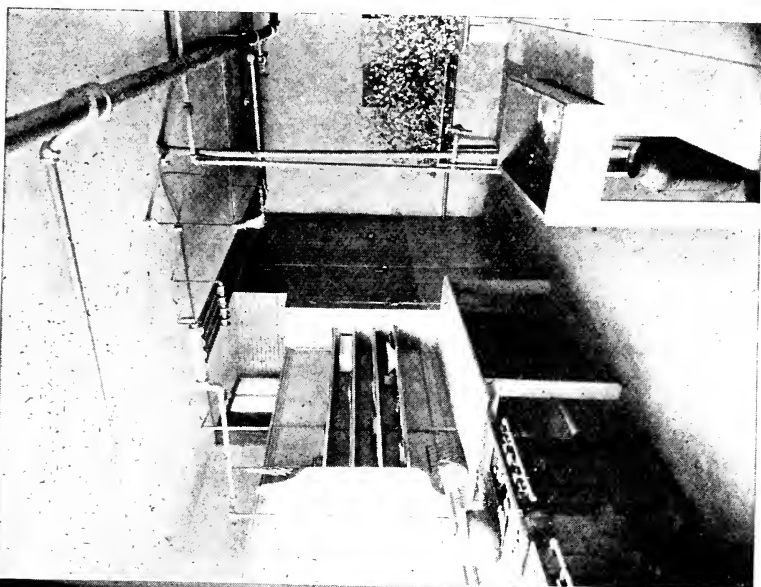
ILLUSTRATION 85. THE SMALL, INADEQUATE KITCHEN OF THE FAULKNER METHODIST CHURCH

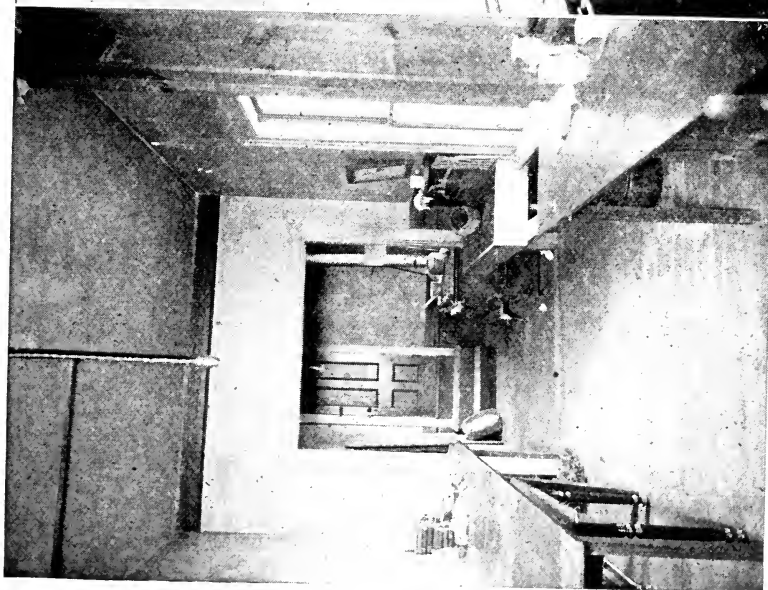
ILLUSTRATION 84. THE POORLY EQUIPPED KITCHEN OF THE LINDEN CONGREGATIONAL CHURCH
